SAFETY ALERT - LIFEBOAT RELEASE MECHANISMS

January 27, 2004 Washington, DC

POTENTIAL SERIOUS SAFETY HAZARD NORSAFE CAMSAFE LIFEBOAT RELEASE MECHANISMS

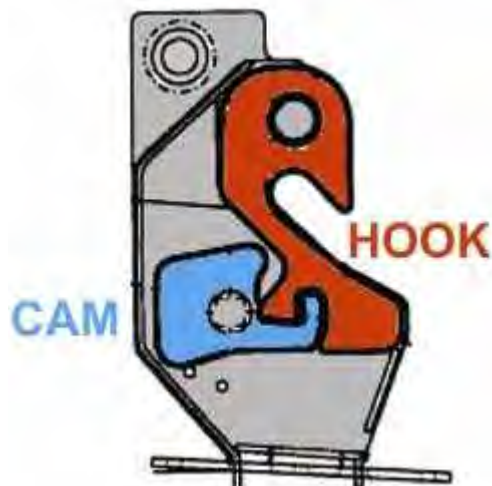
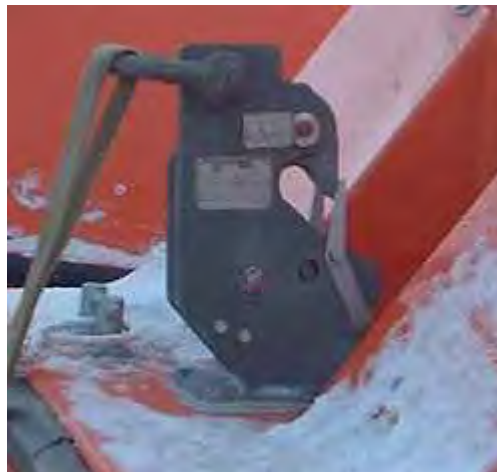
Satisfactory engagement and locking of the release device is dependent upon successful mating between the male and female portions of the cam and hook, respectively, as shown in the following drawing.

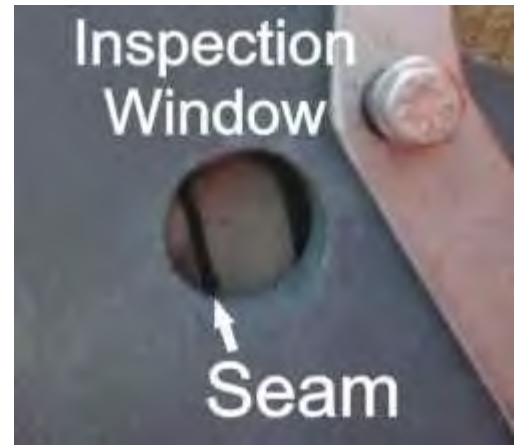
When properly engaged, the seam between the edges of the mating components will be clearly visible in the inspection window located on one side of the release mechanism. Observation of the components within this window will enable confirmation of complete cam-to-hook engagement and look as depicted on the right.

It is important to note that this window is impossible to see from inside the lifeboat and the associated lifeboat and release mechanism manuals are not clear on what the viewer should look for to ensure proper engagement.

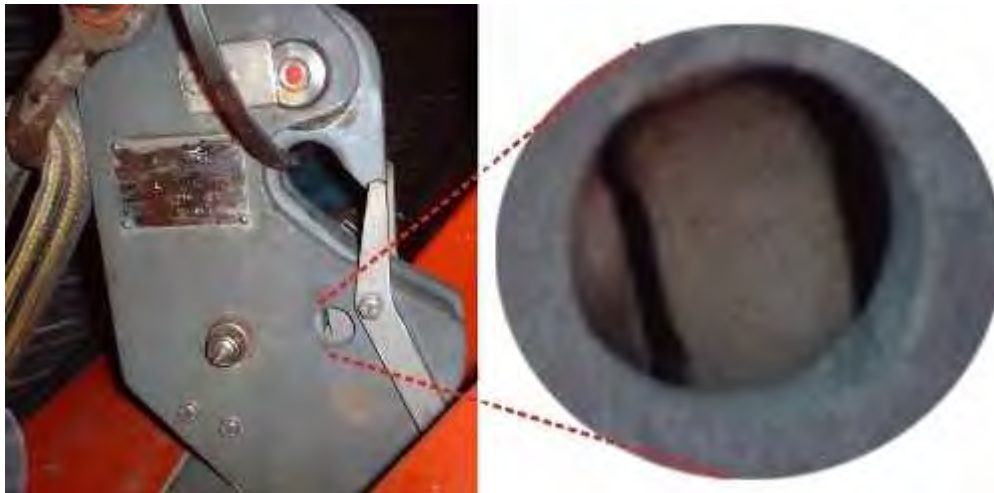
1. With the lifeboat in the STOWED position, and MAINTENANCE PENDANTS FITTED, check the inspection window of the hook (which may be outboard) to determine whether the cam and hook are completely engaged.

2. A properly engaged cam and hook will look like this:

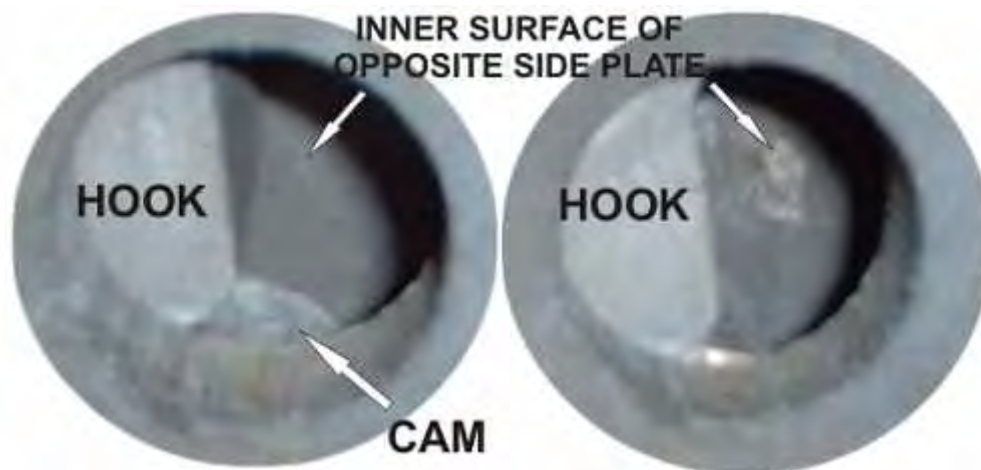
3. An improperly engaged hook and cam may look like this:

IMPORTANT - The inside surface of the opposite side plate (or half) of the release mechanism will be visible, unless a significant portion of the hook is out side the side plates.

4. If the cam and hook are not completely engaged, the load of the boat must be temporarily transferred from the release mechanism and on to the maintenance pendants. Next the release lever at the helmsman's station is reset while the hook is pushed into place by hand to ensure the cam and hook are completely engaged. The load may then be returned to the release mechanism after confirming complete cam engagement through the inspection window.
